SUBJECT: First Five-Year Review Report  
Piper Aircraft Superfund Site  
Vero Beach, Indian River County, Florida

**First Five-Year Review Report for  
PIPER AIRCRAFT NPL SITE  
The New Piper Aircraft, Inc.  
Vero Beach, Indian River County, Florida**

**December 2003**

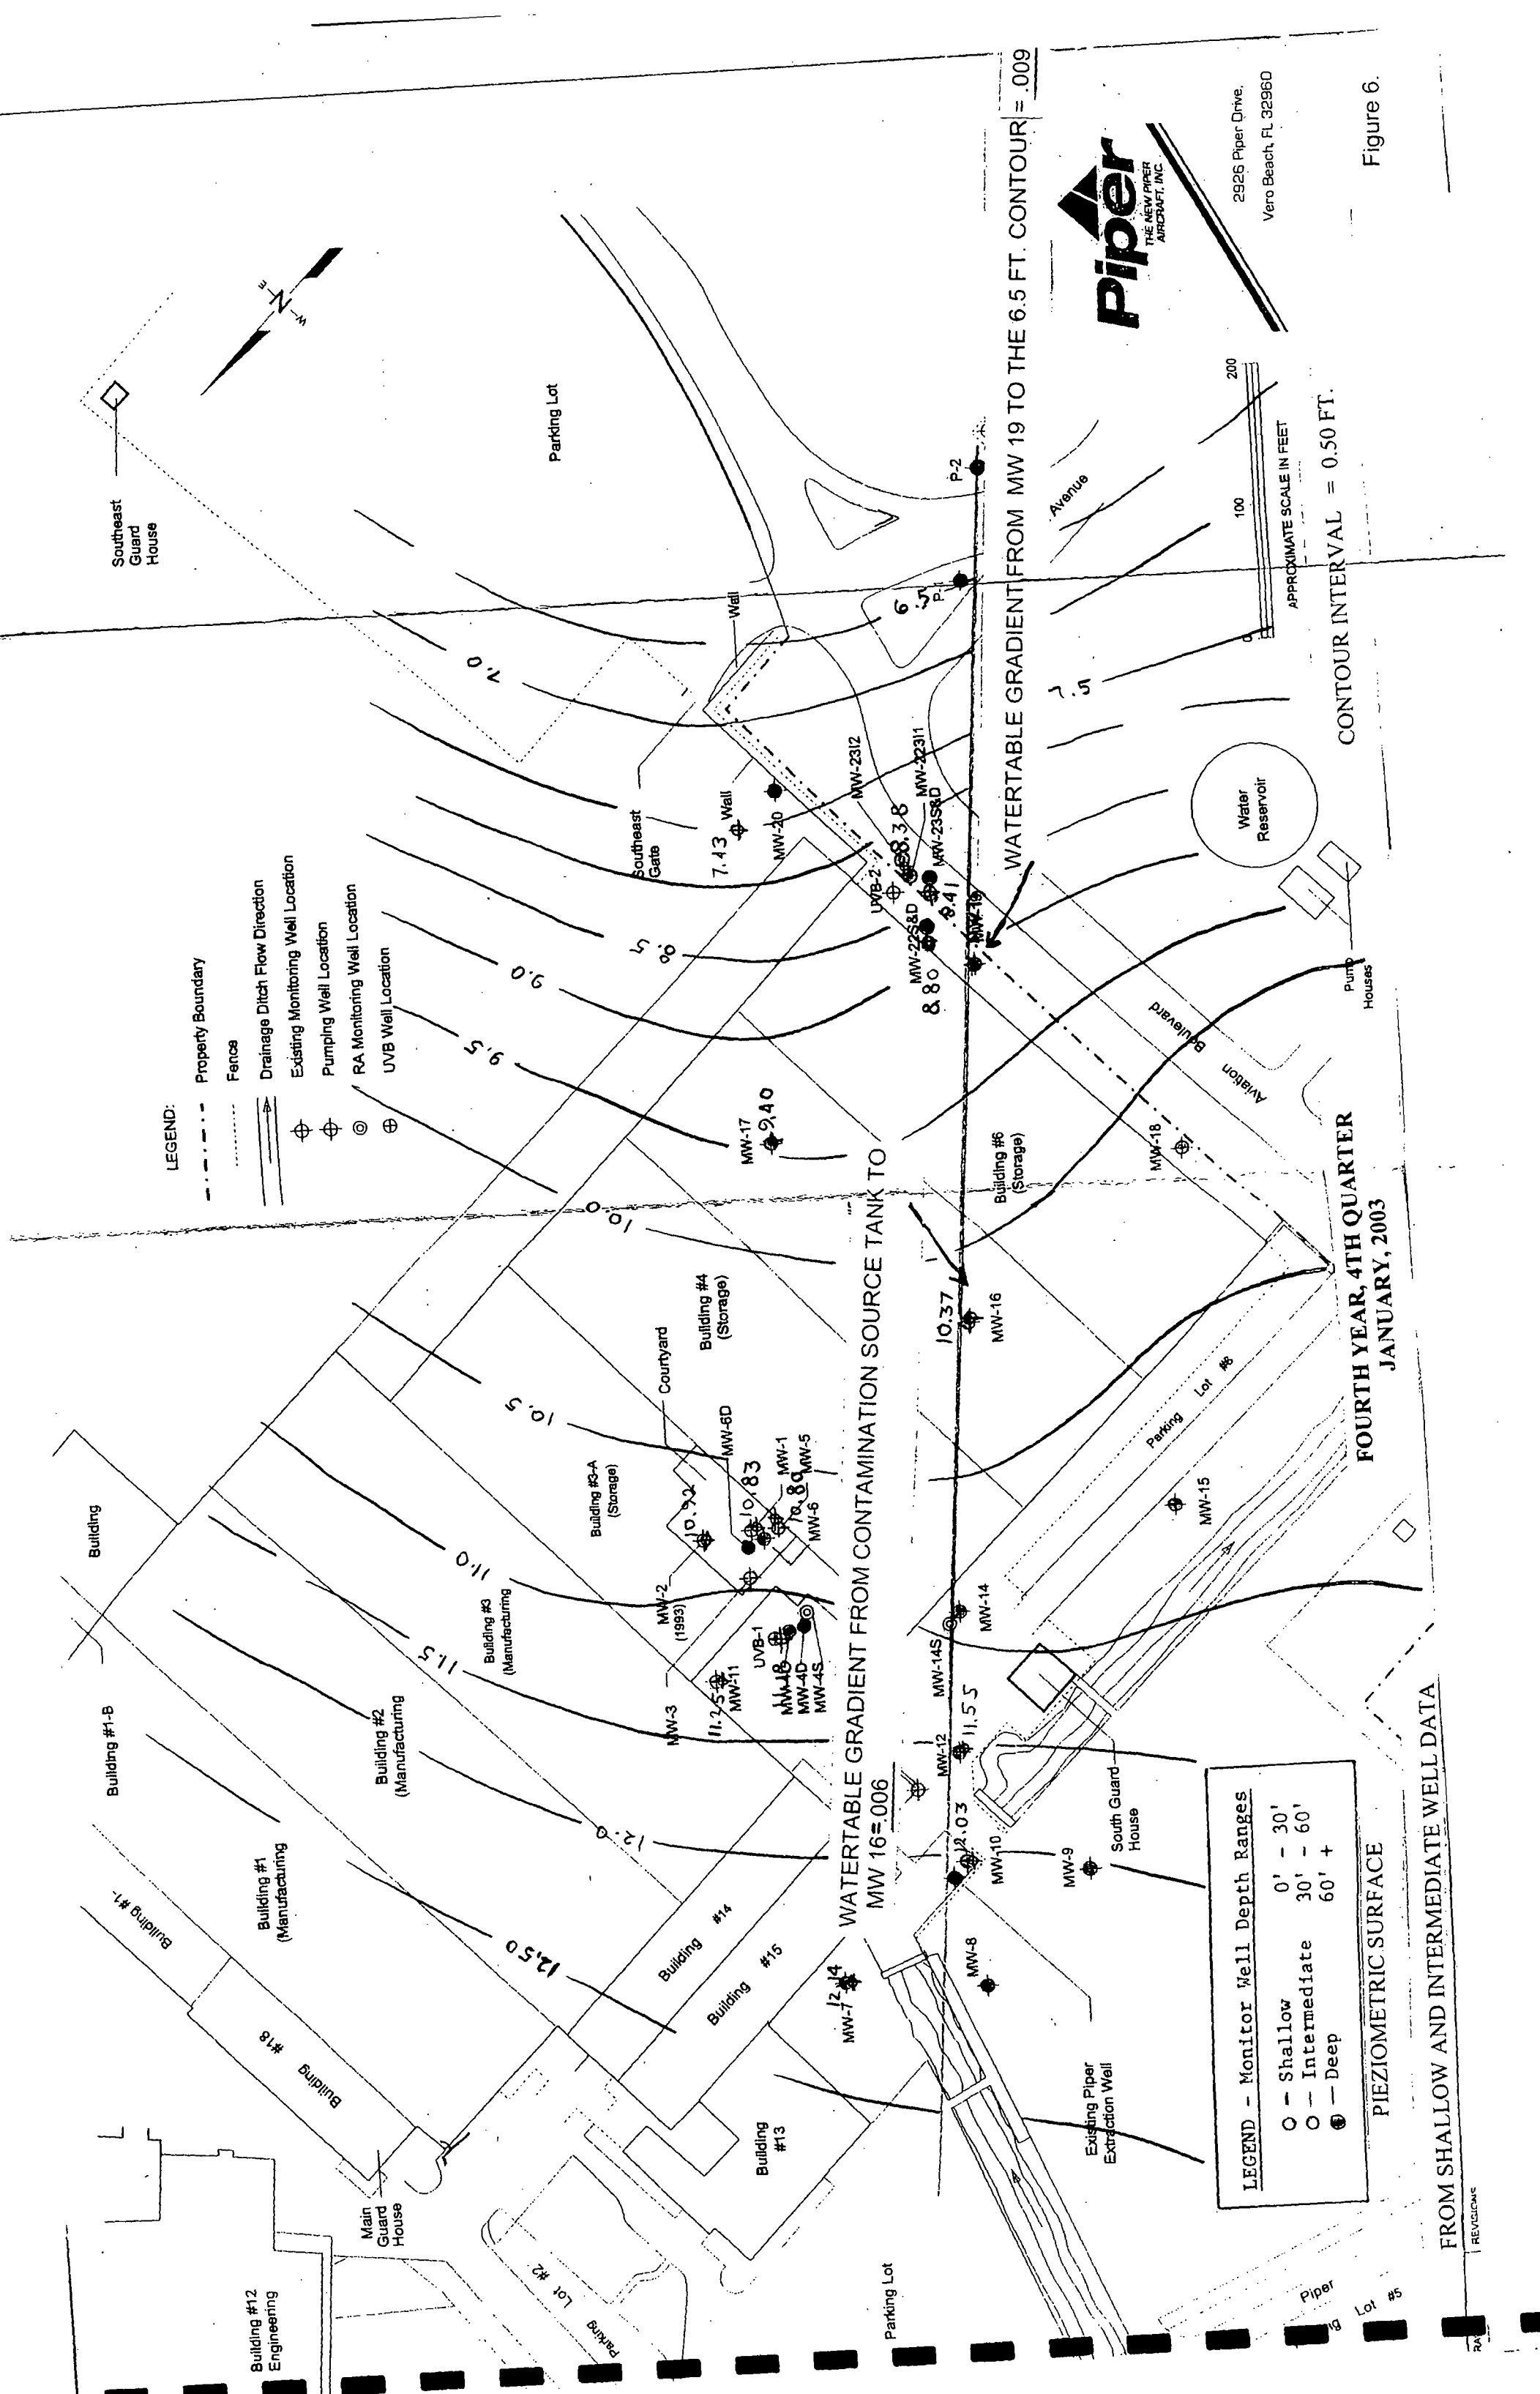
Figure 6.

Water-level data from the Site are presented in Table 2 of the Five-Year Review Report, and in various report figures (Appendix A figure) and in Figure 5 and Figure 6 at the back of the report. Relative to the issue of recovery of contaminated ground water by the UVB wells, the figure in Appendix A shows two cones of depression around the UVB wells (UVB-1A and UVB-2). The representation of water-level contours on this figure is probably fundamentally correct. However, there are a limited number of data points used to construct this figure (six measurements are plotted on the figure), which makes most of the figure a highly subjective interpretation.

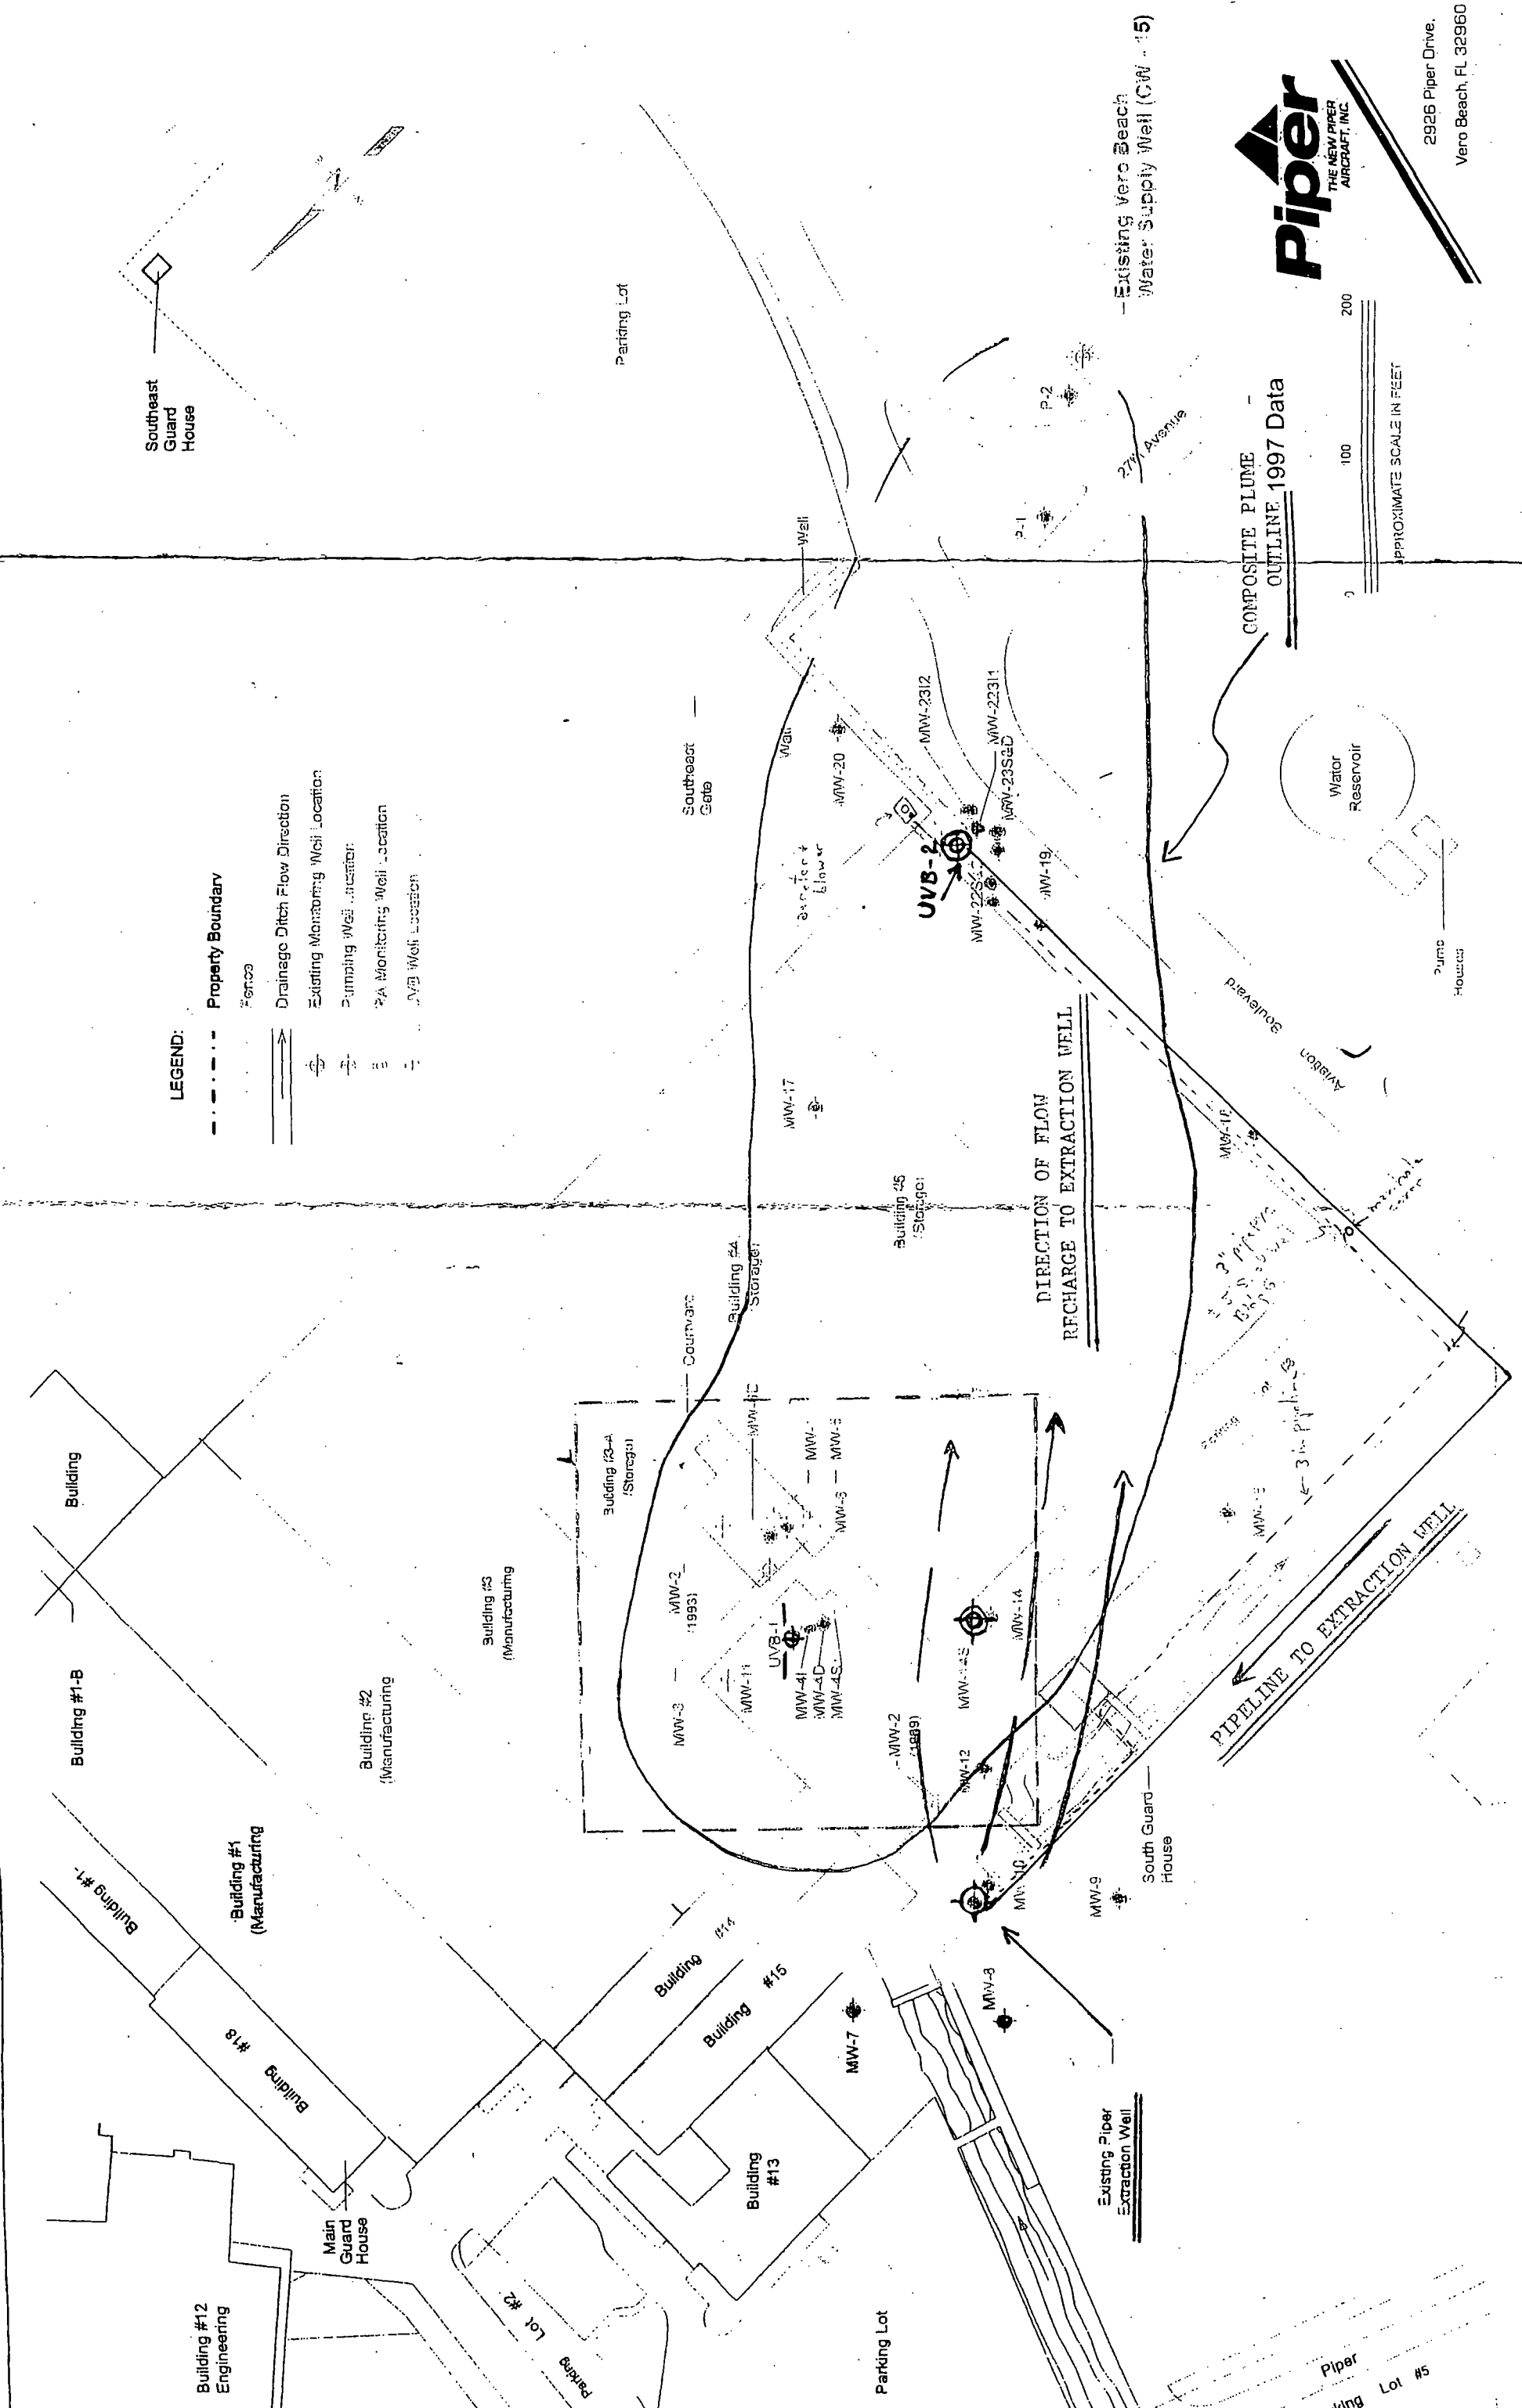
FIGURE 13

The treated groundwater discharge from the aeration unit is piped approximately one thousand feet to the unused Old Piper Extraction Well for gravity disposal, see Figure 13. This significantly improved reliability *and* the pumping rate of UVB-2. A high iron concentration of 1.1 parts per million (ppm), in the groundwater has necessitated pump removal on two occasions for cleaning and another time for screen redevelopment during the five year period. The aeration unit trays were also cleaned during these periods to maintain efficient aeration. The well currently operates at a pumping rate of 20 gallons per minute. This flow rate the Old Piper Extraction Well can accept by gravity flow without overflowing at land surface. The system is monitored daily for groundwater flow rate, aerator vacuum and running time. Additionally, monthly depth to water measurements are observed both in well UVB-2 and the Extraction Well.

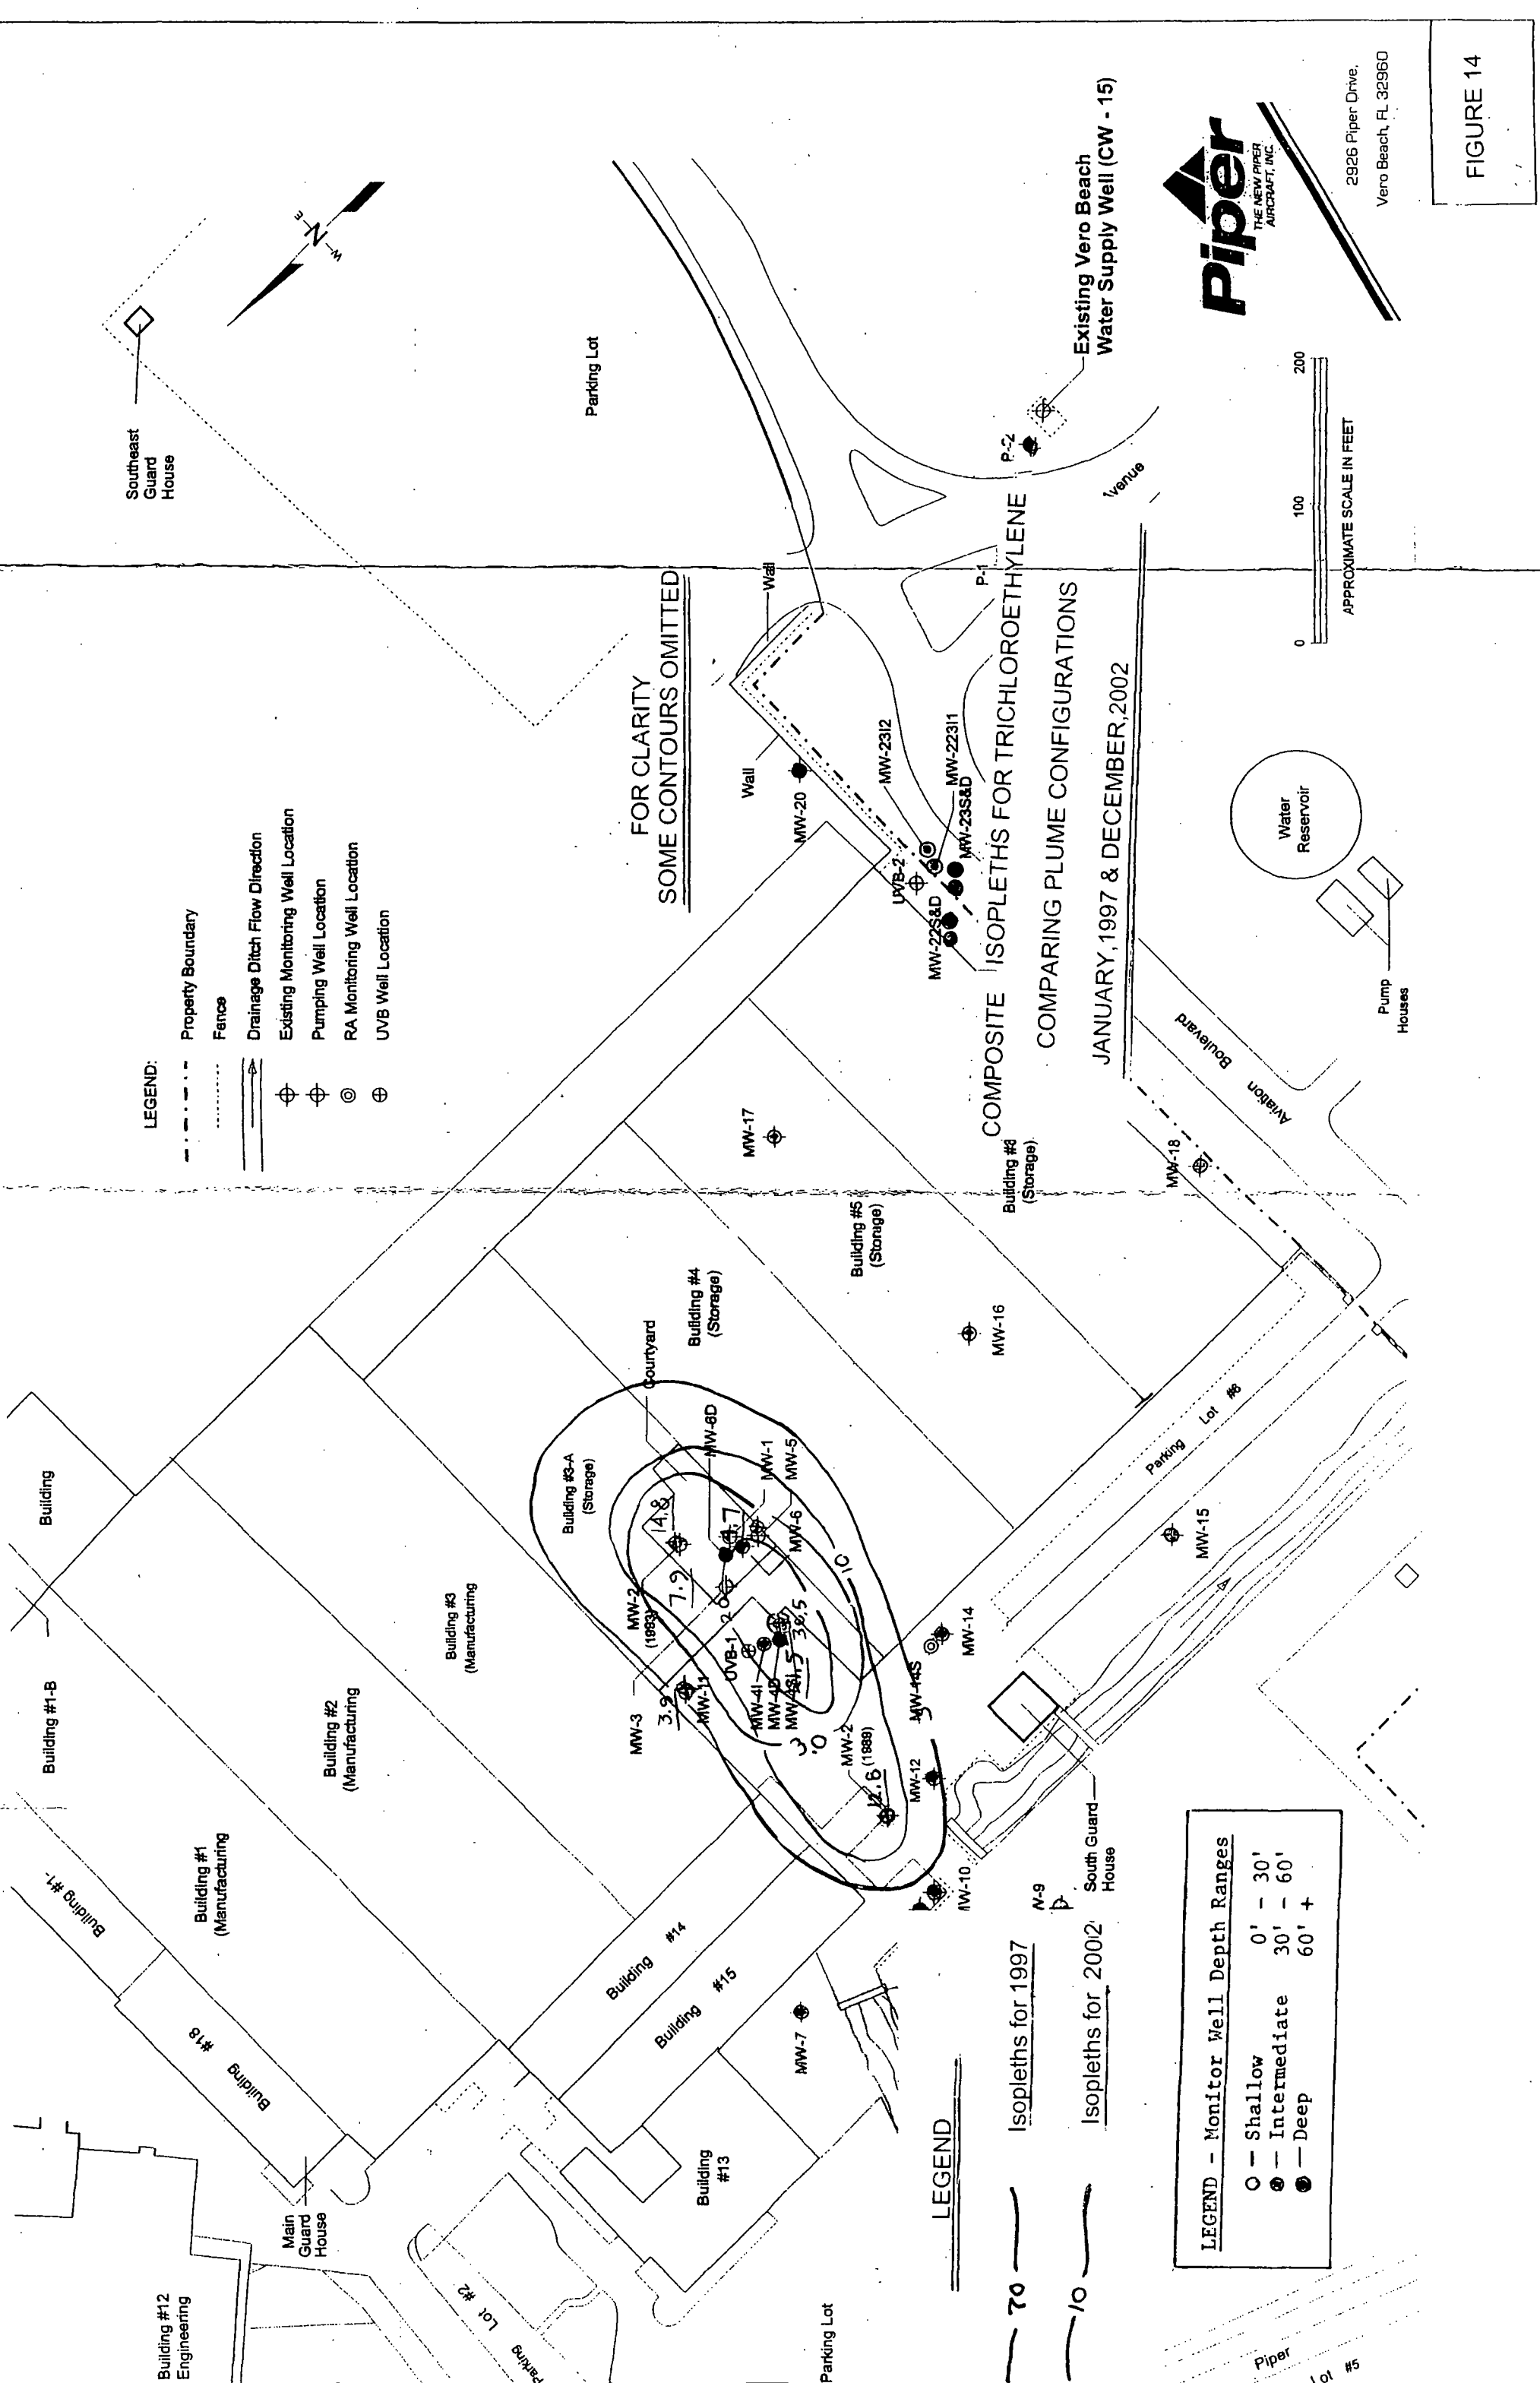
FIGURE 14

The 3 part per billion MCL for this constituent has been exceeded almost exclusively in the shallow groundwater zone near UVB-1, see Figure 14. The persistence of this occurrence might be the result of a localized paucity of indigenous bacteria necessary for more complete conversion to the common breakdown products as seen in other parts of the plume. Figure 14, compares the outline of the 3 parts per billion (ppb) isopleths from the groundwater quality sampling event in January 1997, following the beginning of full operation of the UVB well systems, with the latest isopleth mapping from December 2002. The 1999 event is outlined in black, the 2002 in red. Since the start of remediation, the mapped area for Trichloroethylene has diminished to approximately one-half the area delineated in 1997. A combination of UVB-1 pumping with principal aeration occurring in the well casing and natural attenuation probably contributed to this isopleth configuration in the latest rendition.

The occurrence of Trichloroethylene above the ARARs (3 ppb), is confined to a small area in the vicinity of well UVB-1. These residual remnants of the original plume have not demonstrated any downgradient movement with the groundwater flow, however the concentration has decreased, see Figure 14. Natural attenuation and well UVB-1 pumpage are the mechanisms thought to be responsible for this condition. Target cleanup levels will probably not be attained by pump and treat methodology within the next five-year period without possible input of oxygen or hydrogen enhancing, bio-remediative technology.

- 1.12 In the discussion of the trichloroethylene contamination on page 19, the text references January 1999. Figure 14 indicates that one set of contours represents conditions in January 1997. This discrepancy should be corrected.

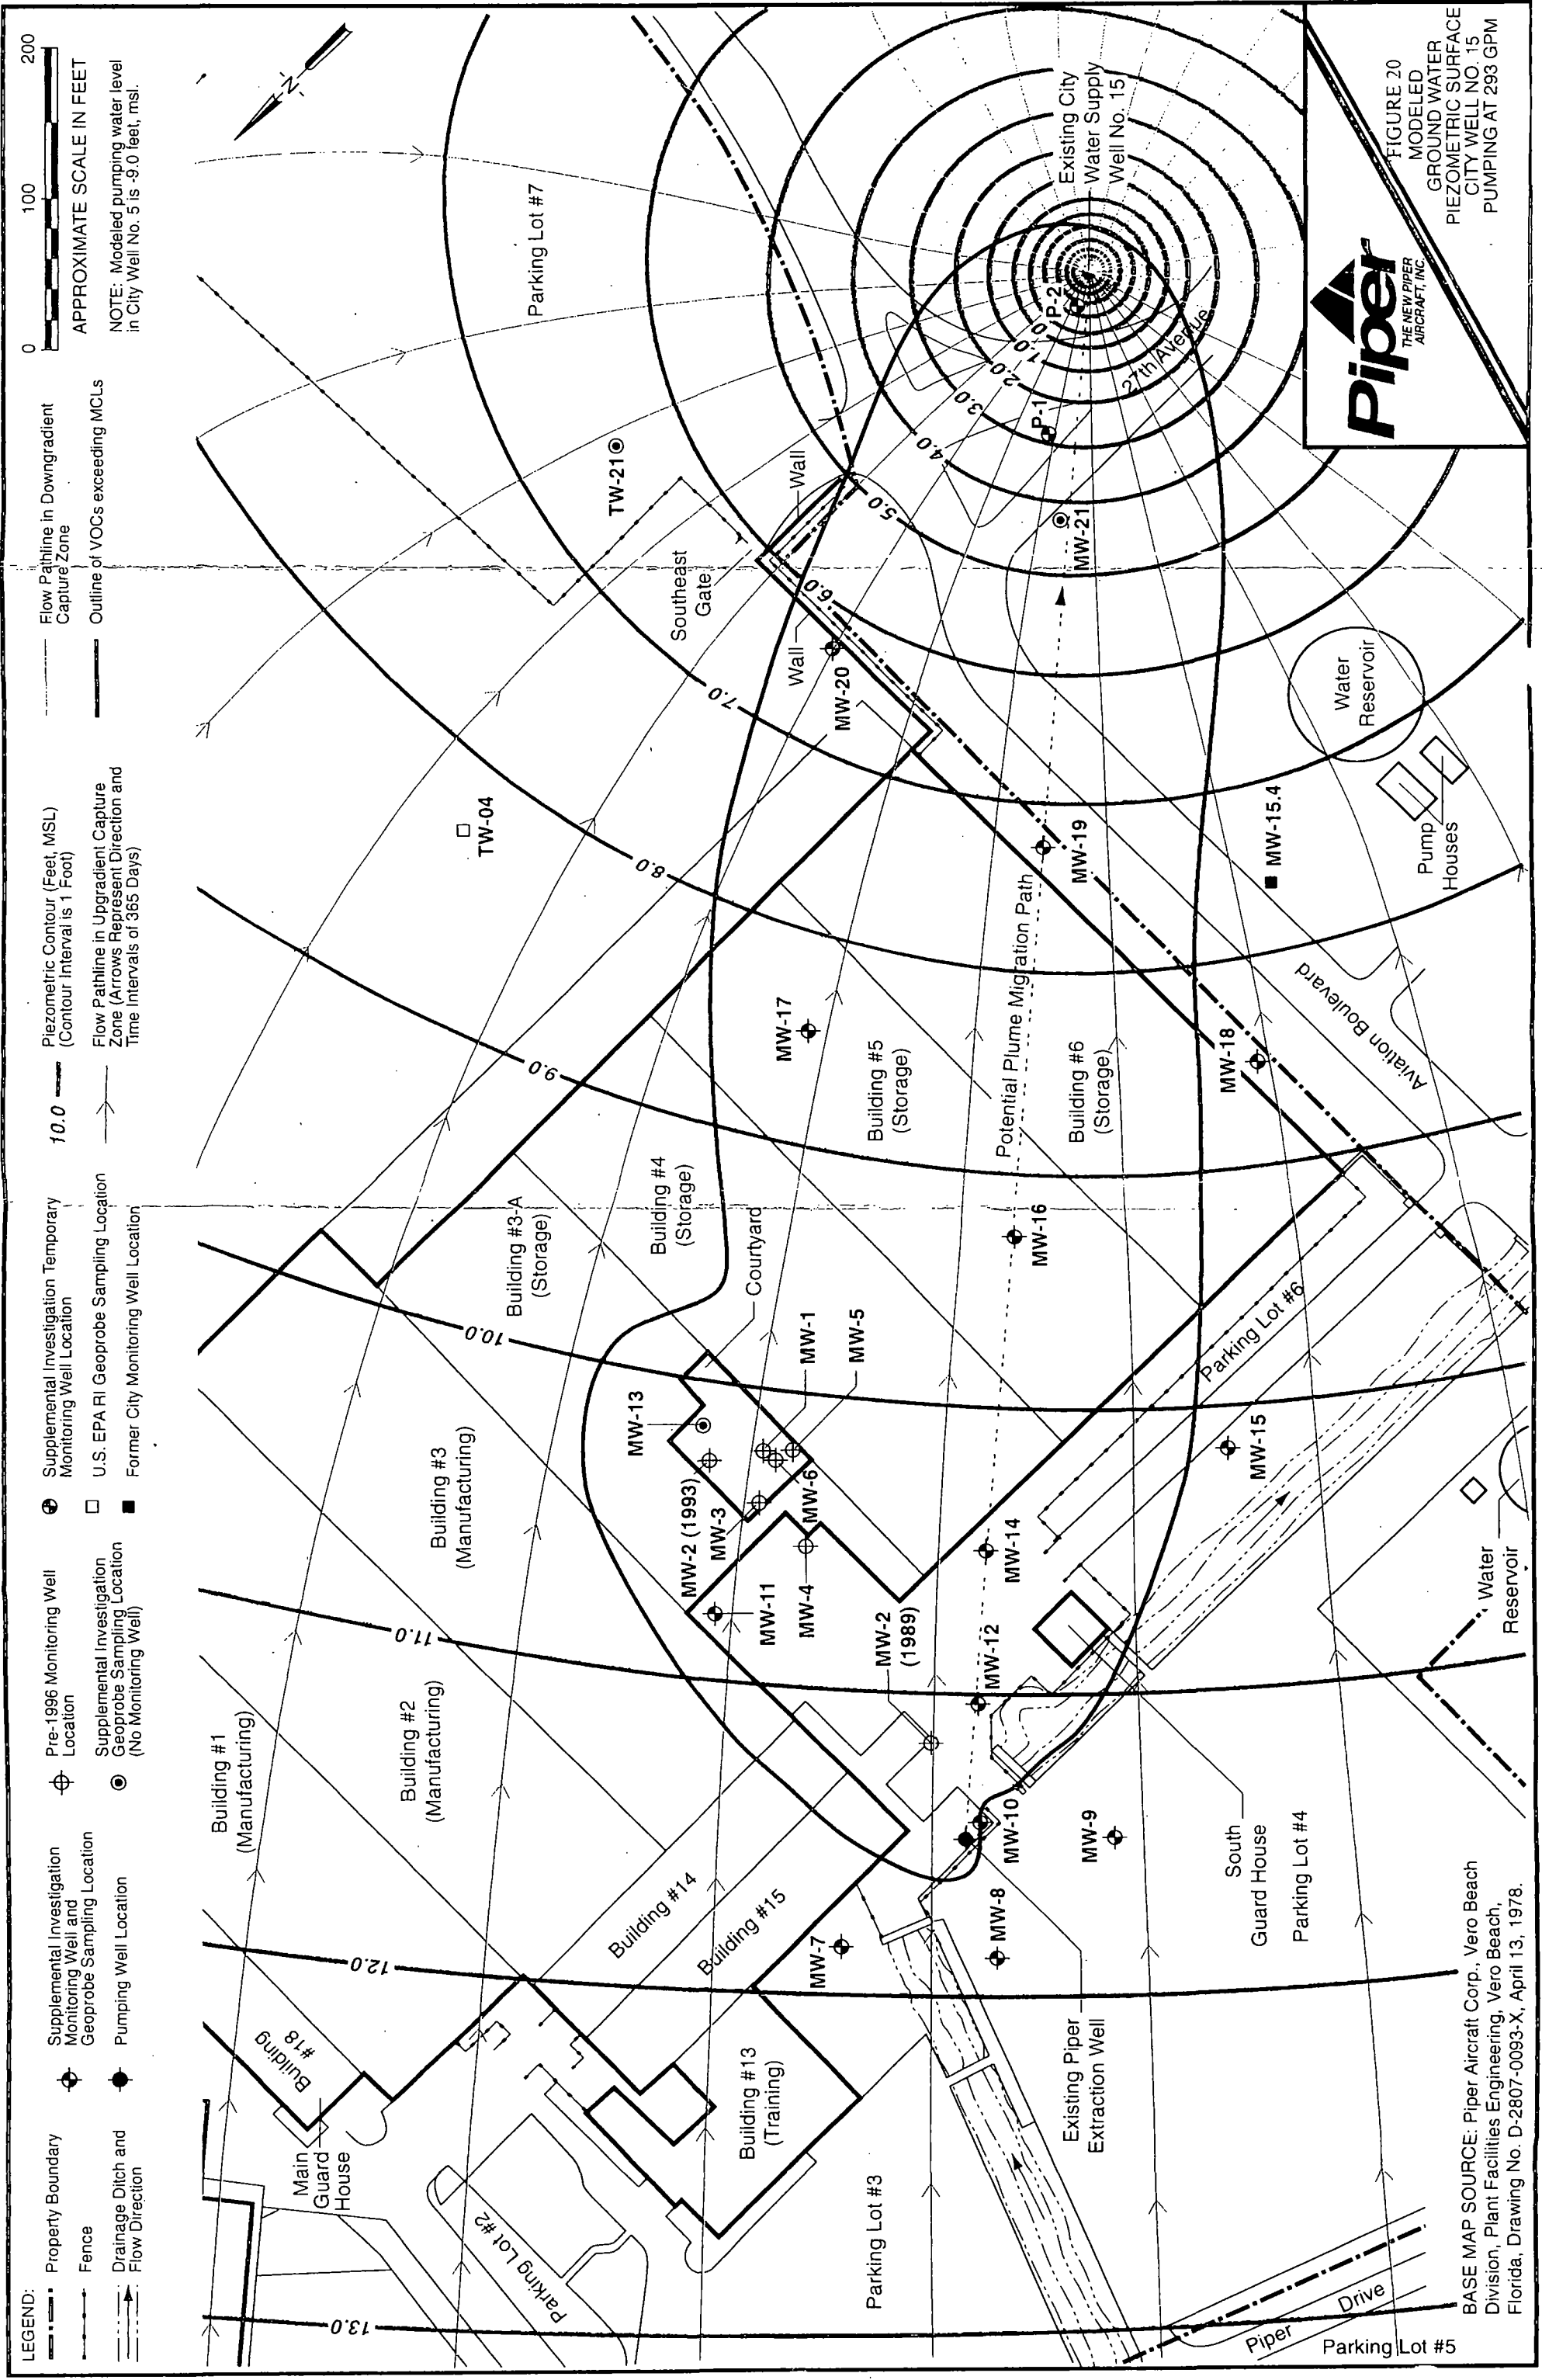
FIGURE 20  
MODELED  
GROUND WATER  
PIEZOMETRIC SURFACE  
CITY WELL NO. 15  
PUMPING AT 293 GPM

*The various pumping rates over the past five years have varied from 5 to 35GPM. The present pumping rate of 20GPM has been maintained since April, 2003. If water level data is collected just before the well pump cycles off, a cone of influence from deep well data maps a cone of influence of approximately 50 feet in diameter. With CVB Well 15 on, the capture zone around UVB-2 is probably not much larger than observed cones of influence. Shallow and intermediate well data shows little to no disturbance of water level contours. As noted, the well processes some contaminants, but a minor portion of that which mixes with non-contaminated water within the capture zone of CVB-15, see Figure 20.*

*Figures 20 and 21 have been added to the Five Year Review Report to represent the best existing interpretation of the CVB Well 15 capture zone in the form of flow net modeling from data collected during pumping tests of CVB Well 15 with data collection from existing and former pumping test monitoring wells. These data were originally*
